Report No. CG-D-61-78

COLLISION ACCIDENT
INVESTIGATIONS FOR 1977
SEASON

FINAL REPORT

U.S. DEPARTMENT OF TRANSPORTATION
United States Coast Guard
Office of Research and Development
Washington, D.C. 20590

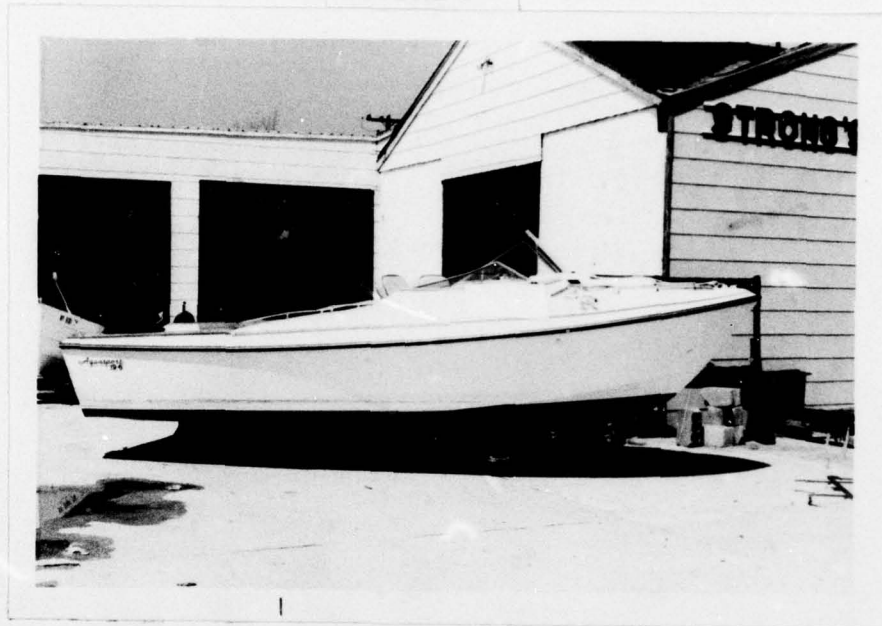
FIGURE 7

AQUA SPORT INVOLVED IN COLLISION

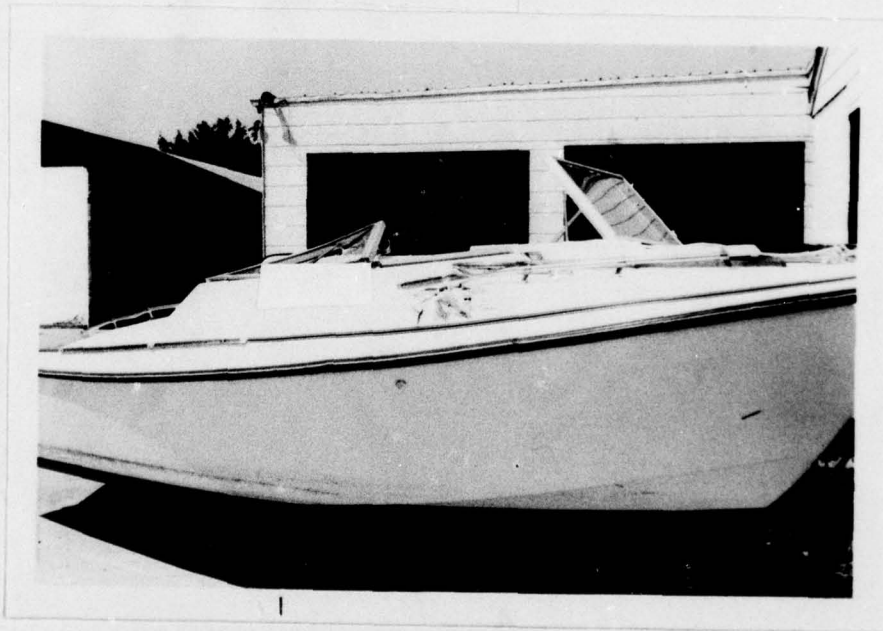
FIGURE 8

Damage to Boat #1 indicated a bow high position of Boat #2 at impact. This would indicate that Boat #2 was traveling at least 10-15 mph (24 kph) at impact.

DAMAGE TO DECK, NOTE ANGLE OF IMPACT

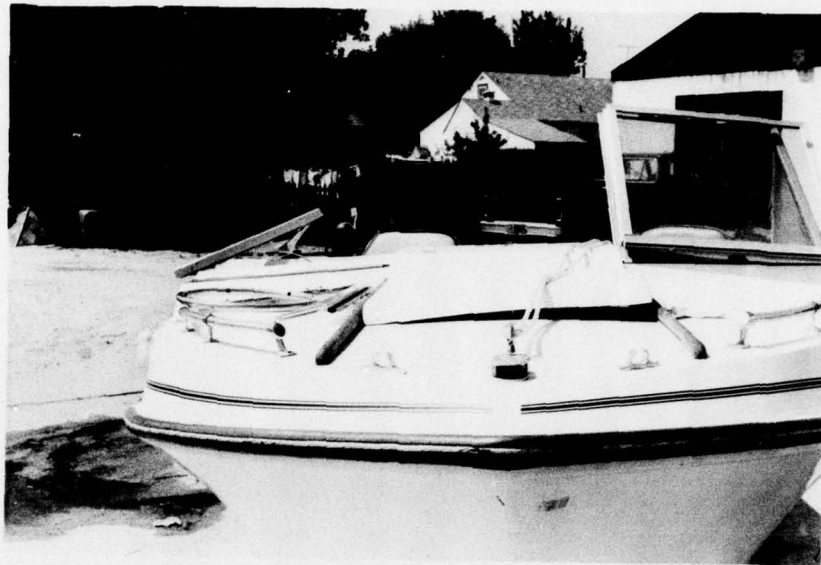
FIGURE 11

HATCH WHERE PASSENGER WAS STANDING

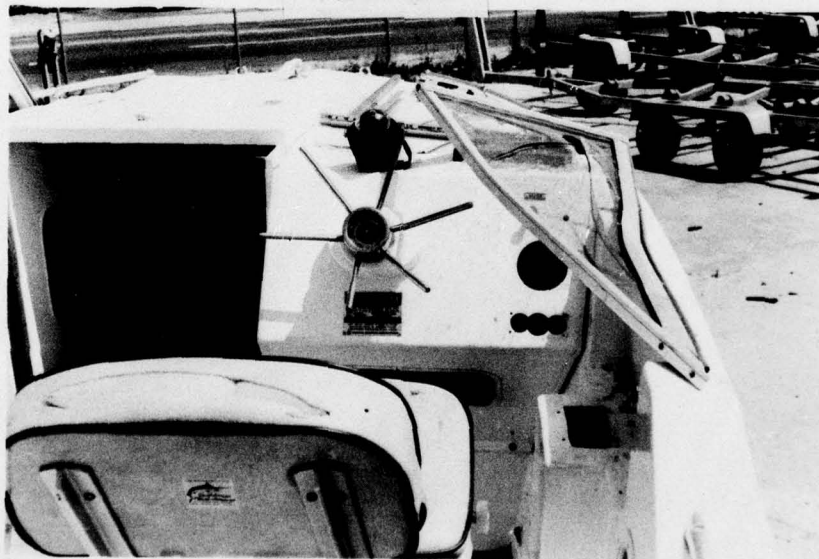
FIGURE 12

DAMAGE TO HELM AND VIEW OF AREA BELOW DECK.
NOTE DAMAGE TO COMPASS WHERE KEEL PASSED
OVER THE DECK, AND DAMAGE TO HELMSMANS
SEAT CAUSED BY THE SEA RAY KEEL AS IT
SLID AFT.

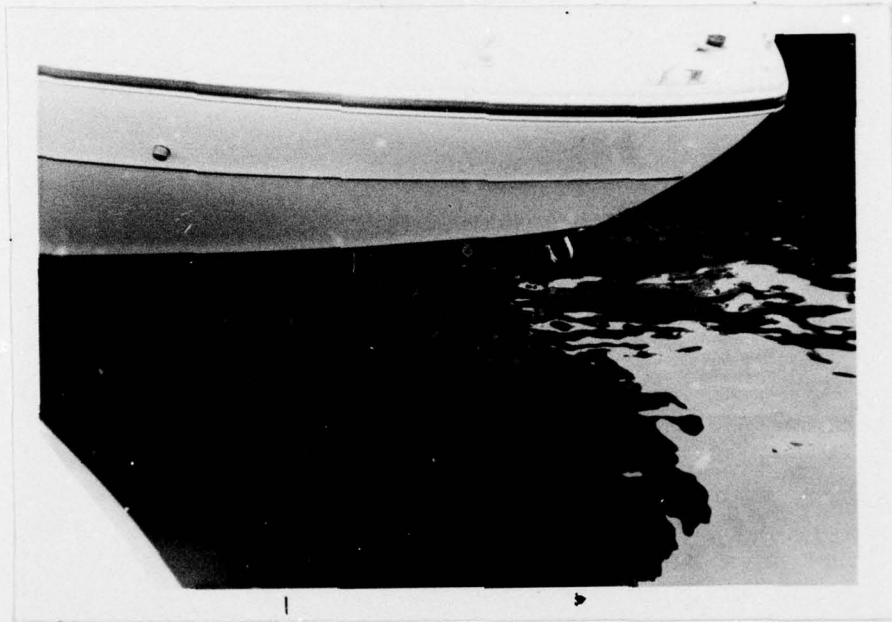
FIGURE 15

19' SEA RAY -- NOTICE SCRATCHES ON KEEL
